EXECUTIVE SUMMARY

OBSERVATIONS & RECOMMENDATIONS

Horseshoe Pond, Canterbury

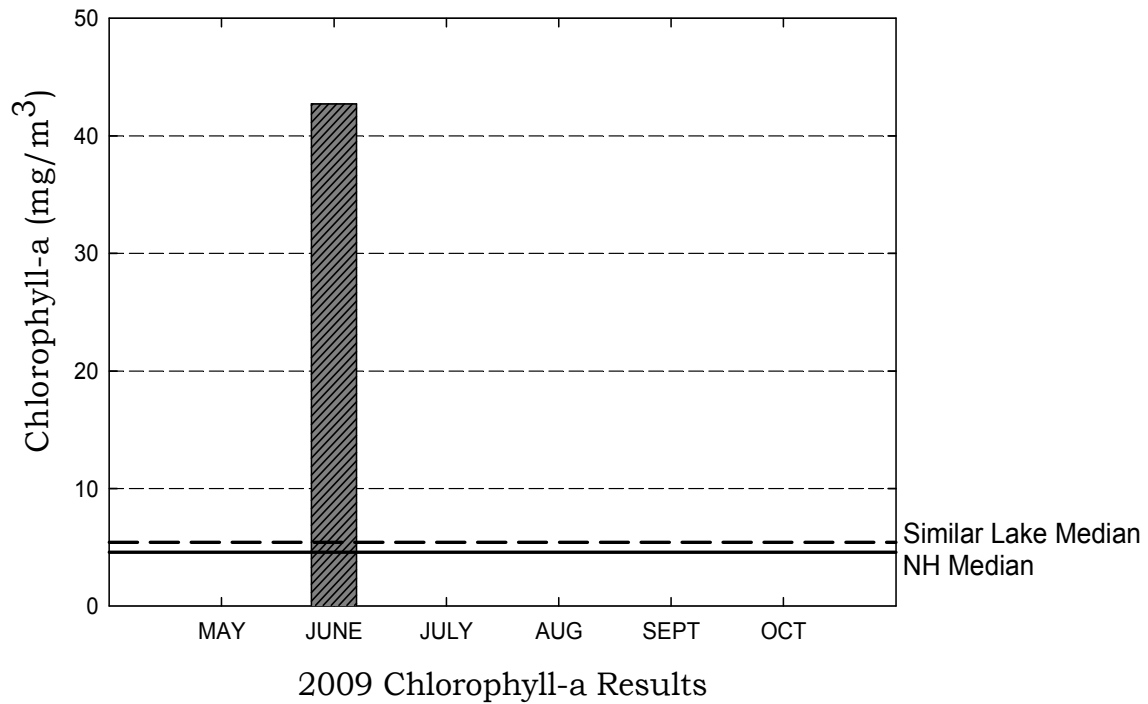
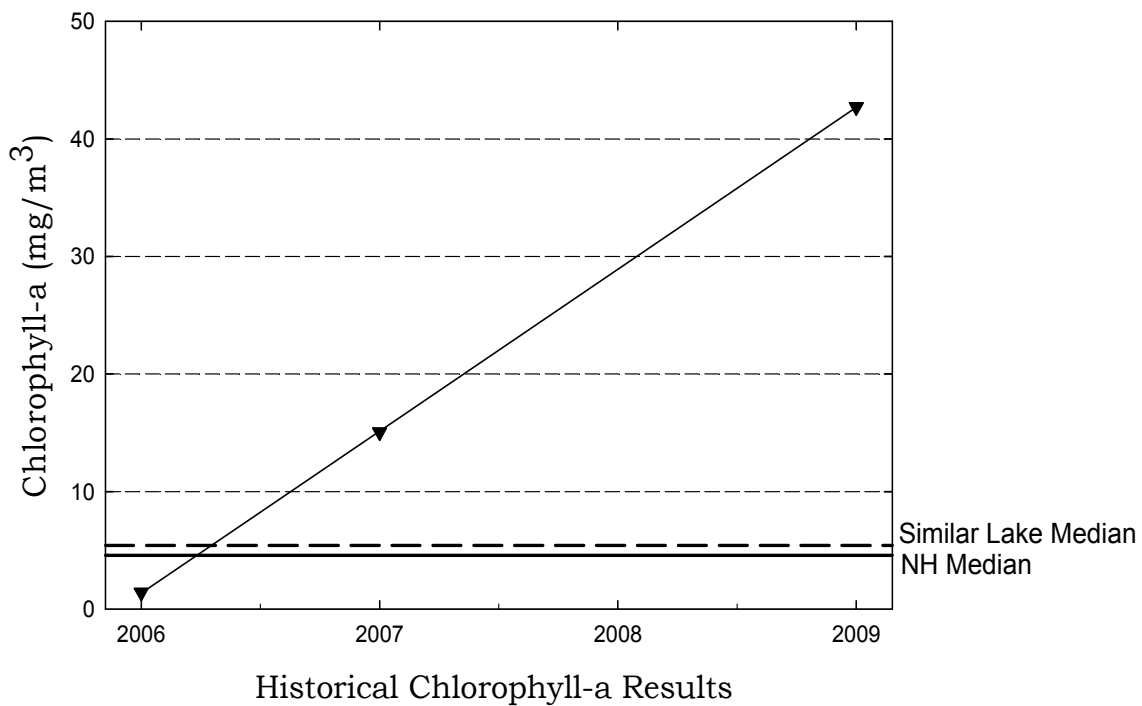
Figure 1. Monthly and Historical Chlorophyll-a Results

Figure 1 depicts the historical and current year chlorophyll-a concentration in the water column.

The current year data (the top graph) show that the chlorophyll-a concentration was **42.70 mg/m³** in **June** indicating an algal bloom had occurred in the pond. Typically, chlorophyll-a concentrations above **15.0 mg/m³** are indicative of an algal bloom.

The historical data (the bottom graph) show that the **2009** chlorophyll-a mean is ***much greater than*** the state and similar lake medians. For more information on the similar lake median, refer to Appendix D.

Overall, visual inspection of the historical data trend line (the bottom graph) shows an ***increasing*** in-lake chlorophyll-a trend since monitoring began. Specifically the mean chlorophyll concentration has ***worsened*** since **2006**.

While algae are naturally present in all waterbodies, an excessive or increasing amount of any type is not welcomed. Phosphorus is the nutrient that algae typically depend upon for growth in New Hampshire lakes and ponds. Algal concentrations increase as nonpoint sources of phosphorus from the watershed increase, or as in-lake phosphorus sources increase. Increased Chlorophyll-a concentrations can also affect water clarity, causing Secchi-disk transparency to decrease (worsen) and turbidity to increase (worsen). Therefore, it is extremely important for volunteer monitors to continually educate all watershed

residents about management practices that can be implemented to minimize phosphorus loading to surface waters.

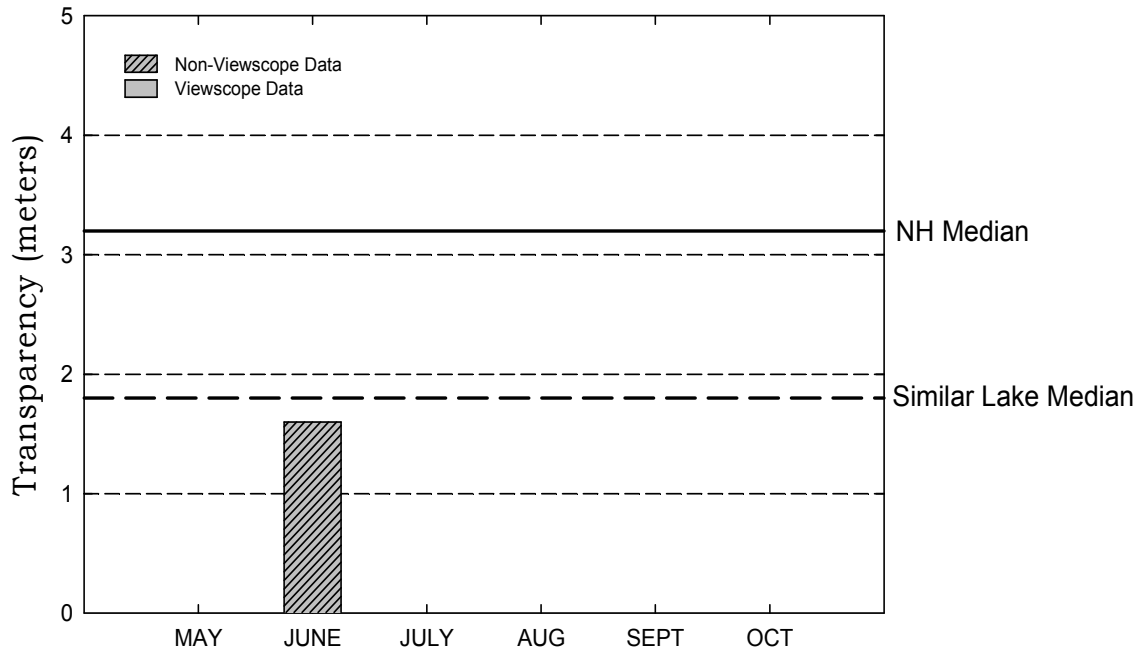
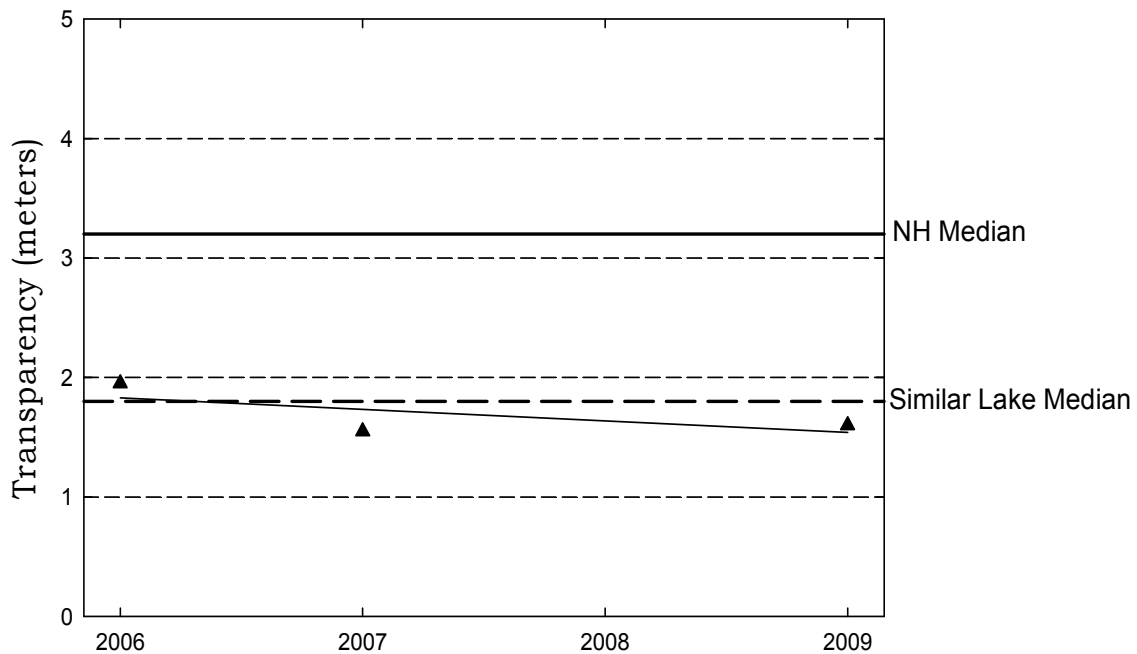
Figure 2. Monthly and Historical Transparency Results

Figure 2 depicts the historical and current year transparency *with and without* the use of a viewscope.

The current year ***non-viewscope*** in-lake transparency was **1.6 meters in June**.

The historical data (the bottom graph) show that the **2009** mean non-viewscope transparency is ***much less than*** the state median and is ***slightly less than*** the similar lake median. Please refer to Appendix D for more information about the similar lake median.

Visual inspection of the historical data trend line (the bottom graph) shows a ***stable*** trend. Specifically, the transparency has ***remained approximately the same*** since monitoring began in **2006**.

Efforts should continually be made to stabilize stream banks, pond shorelines, disturbed soils within the watershed, and especially dirt roads located immediately adjacent to the edge of tributaries and the pond. Guides to best management practices that can be implemented to reduce, and possibly even eliminate, nonpoint source pollutants, are available from DES upon request.

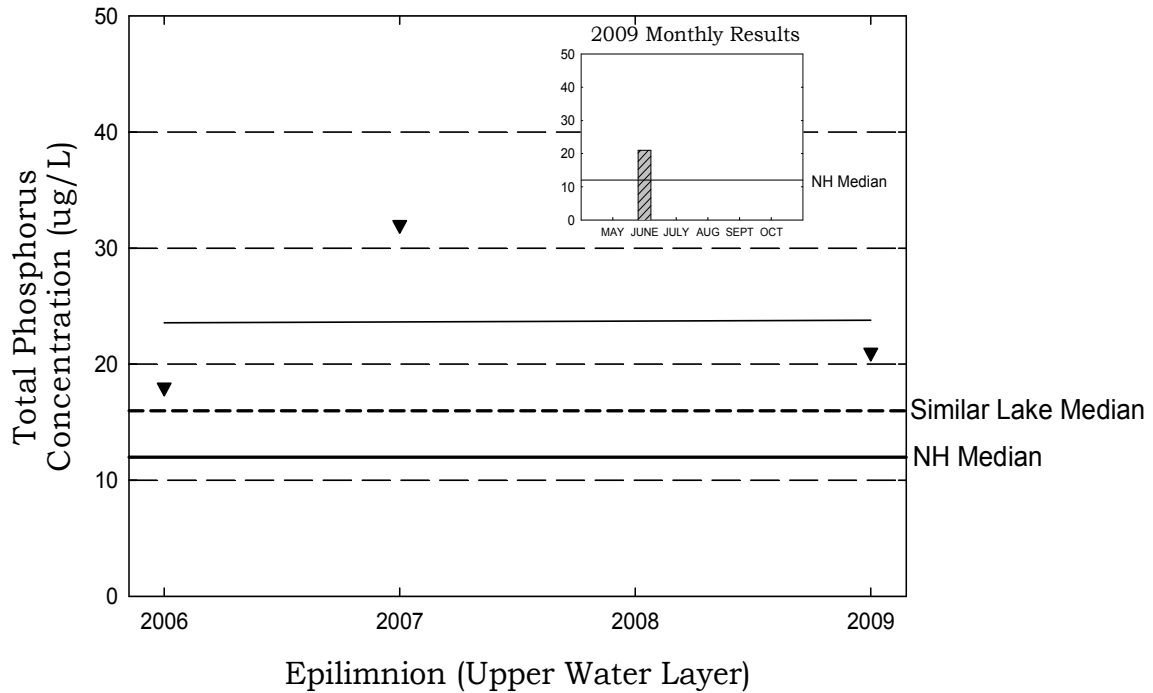
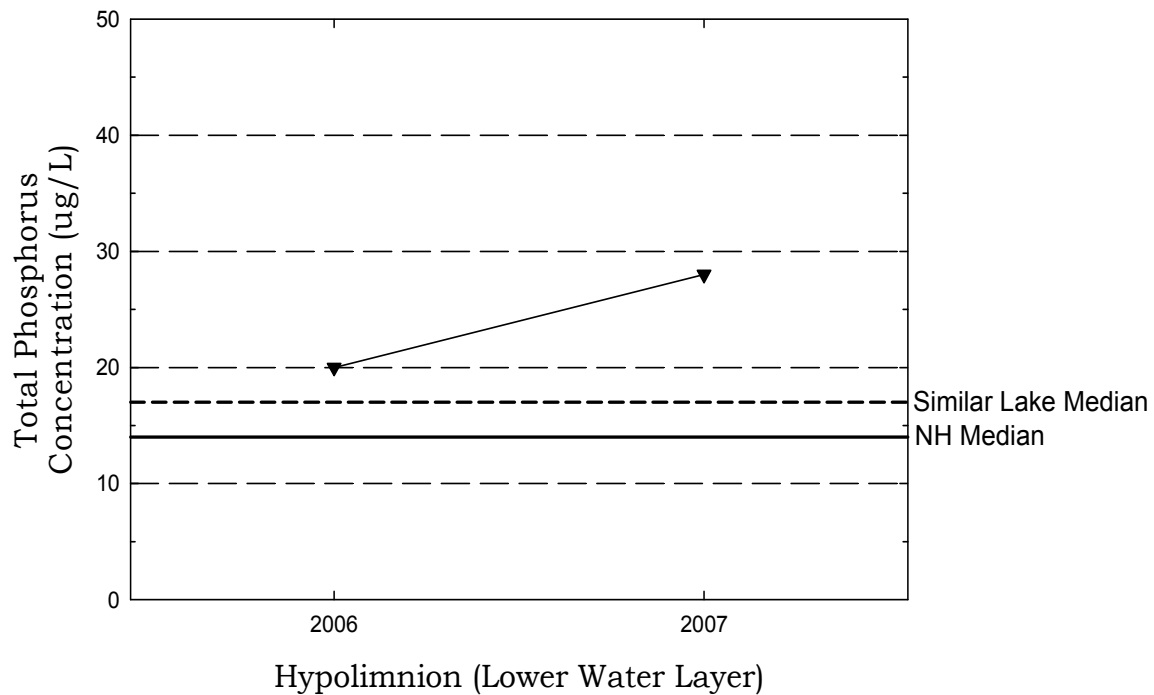
Figure 3. Monthly and Historical Total Phosphorus Data.

The graphs in Figure 3 depict the historical amount of epilimnetic (upper layer) and hypolimnetic (lower layer) total phosphorus concentrations; the inset graphs depict current year total phosphorus data.

The current year data for the epilimnion (the top inset graph) show that the phosphorus concentration was **21ug/L** in **June**.

The historical data show that the **2009** mean epilimnetic phosphorus concentration is **greater than** the state and similar lake medians. Refer to Appendix D for more information about the similar lake median.

Overall, visual inspection of the epilimnetic historical data trend line shows a **variable** phosphorus trend. Specifically, the mean annual epilimnetic phosphorus concentration has **fluctuated between approximately 18 and 32 ug/L** since monitoring began in **2006**.

One of the most important approaches to reducing phosphorus loading to a waterbody is to continually educate watershed residents about the watershed sources of phosphorus and how excessive phosphorus loading can negatively affect the ecology and the recreational, economical, and ecological value of lakes and ponds.
